Near-Miss Video Screening – A Safety Improvement Tool for Delaware’s Intersections

Emily Hufnal, EIT

DelDOT

Quality Counts, LLC

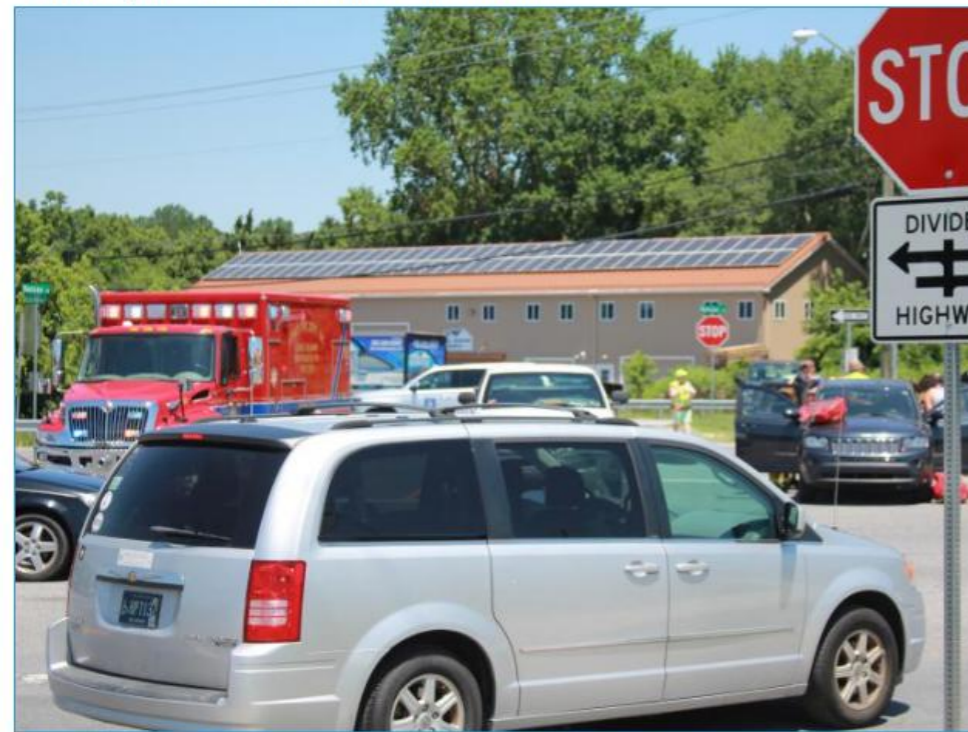
Traffic piles up at Nassau Road after a crash in the crossover in July. MELISSA STEELE PHOTO

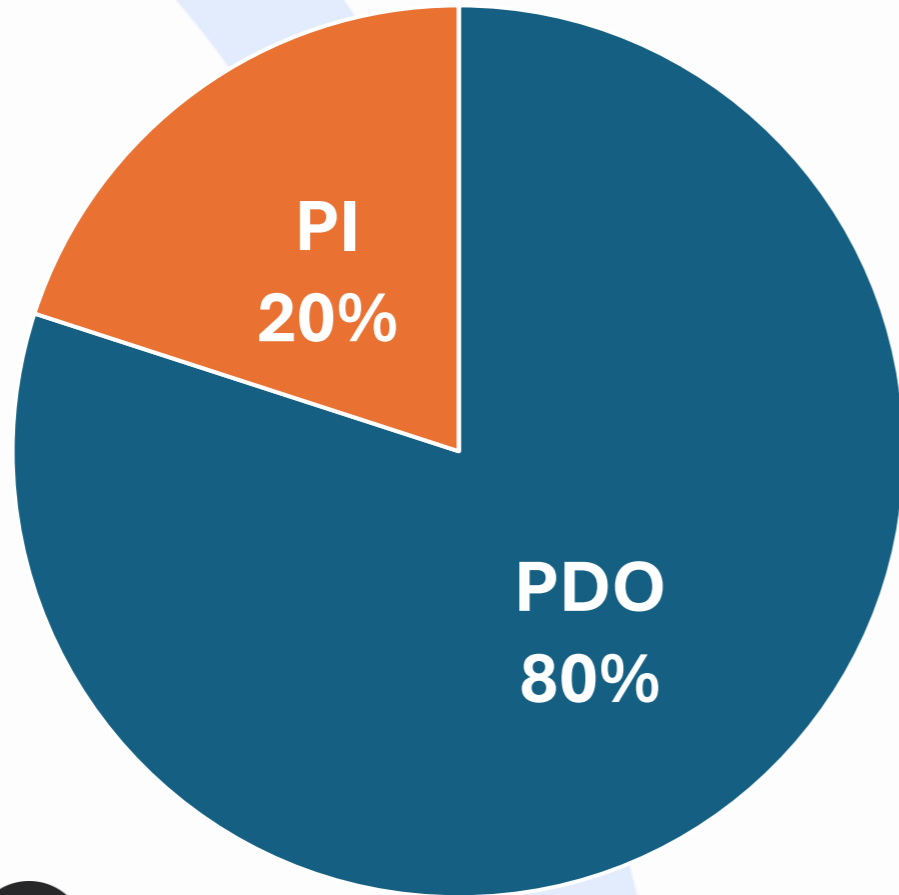
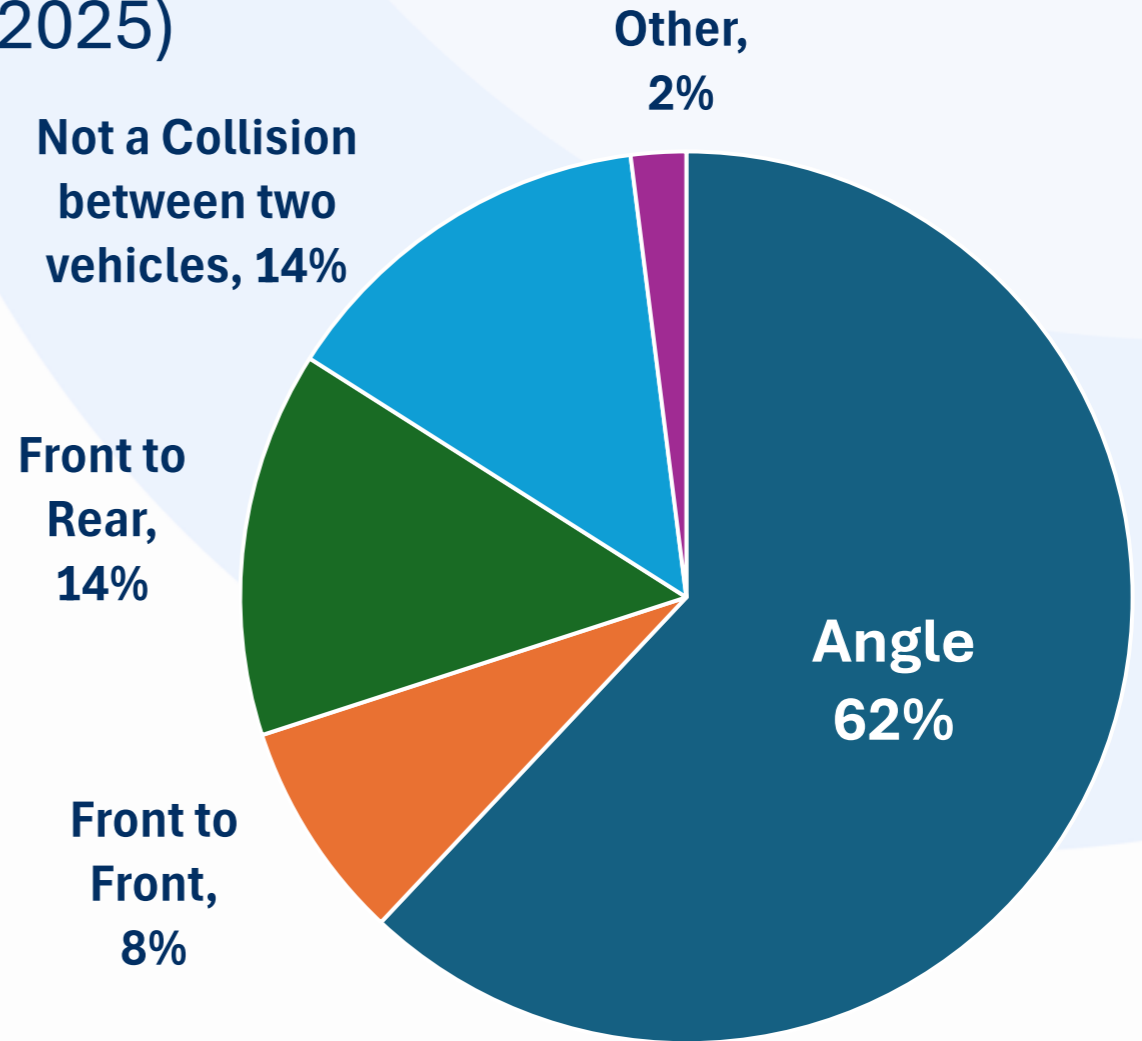
Crash Summary

- 50 total crashes (June 2022 – June 2025)

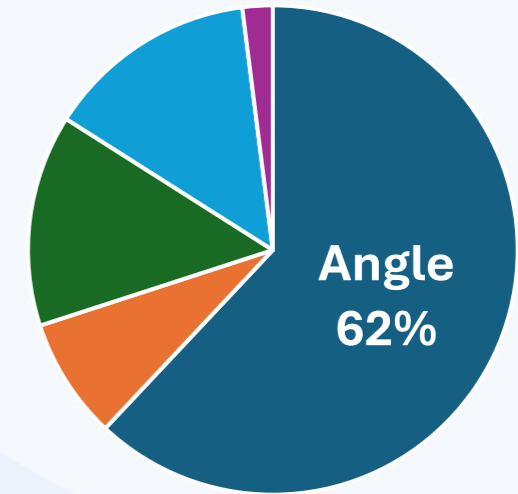
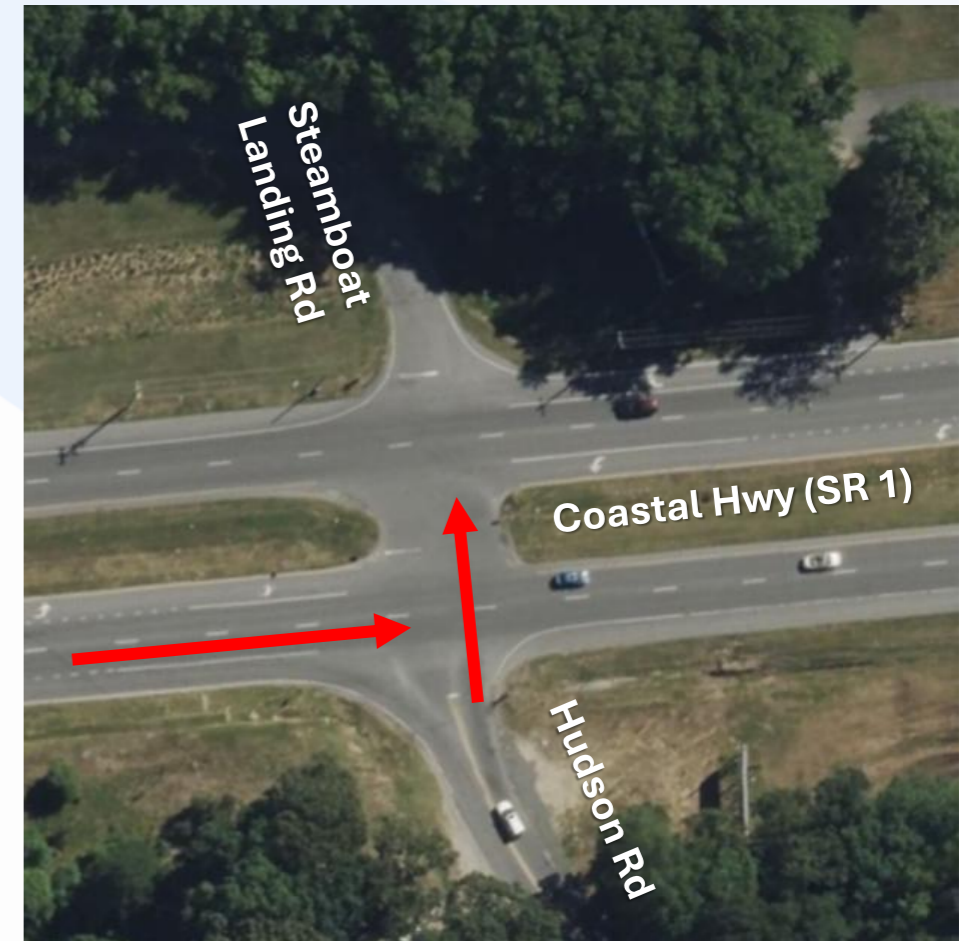
Crash Summary

- **50 total crashes** (June 2022 – June 2025)
- 31 angle crashes, 28 of which were median related
 - **24 SB / EB crashes** ←
 - 1 SB / WB crash
 - 3 crashes within the median

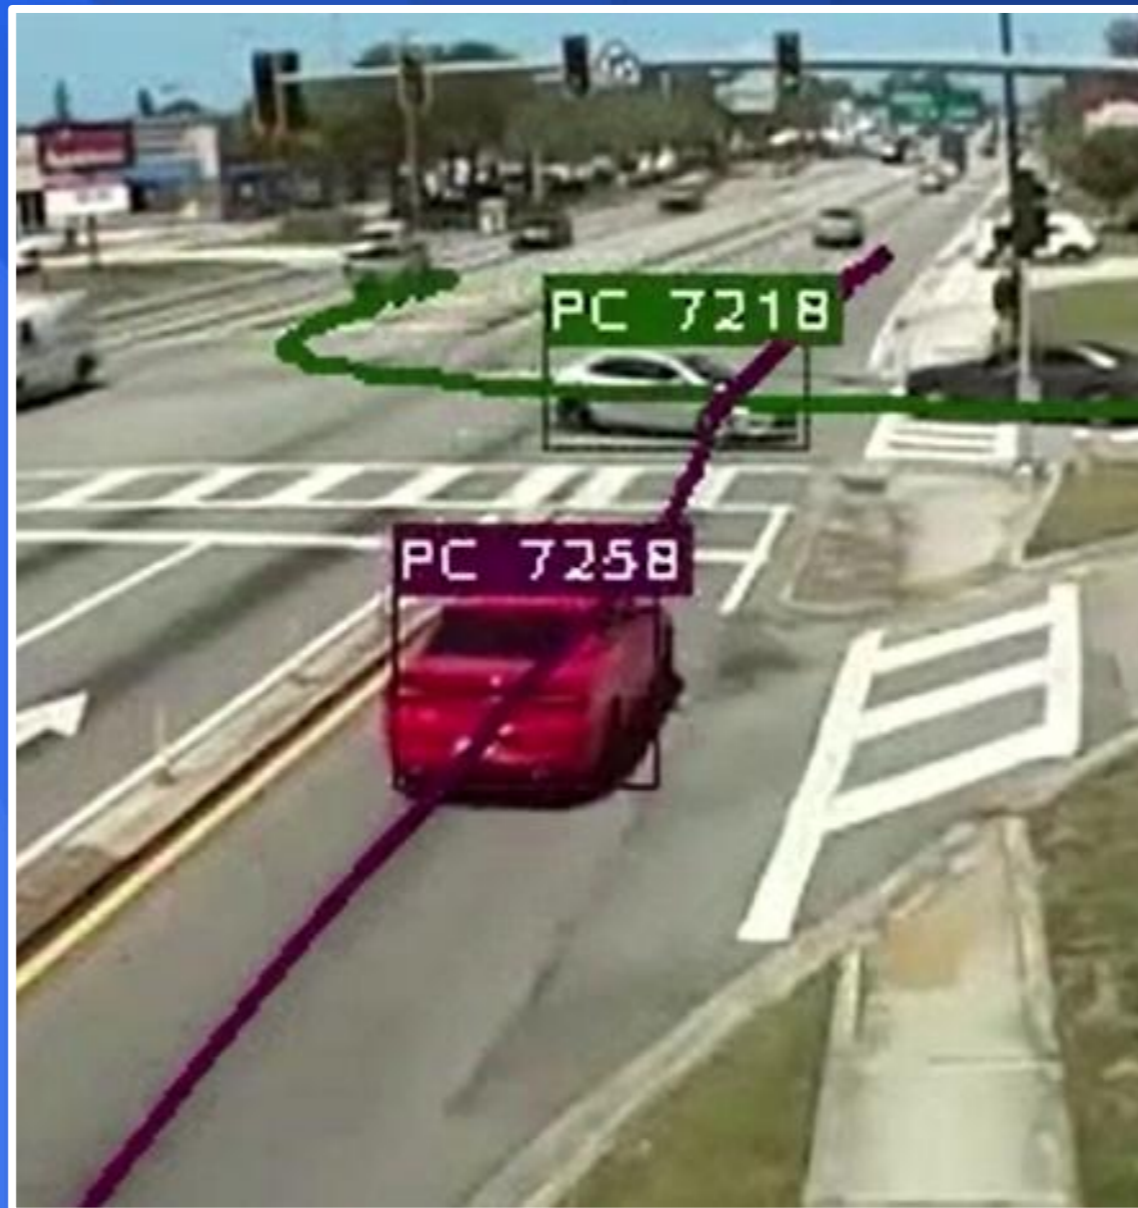
Hudson Rd – DE 1

Site Name	Total Hours Studied	Total Conflicts			Veh - Veh Conflicts			Ped - Veh Conflicts			Bike - Veh Conflicts		
		0.0 - 1.5s	1.5 - 2.0s	2.0 - 3.0s	0.0 - 1.5s	1.5 - 2.0s	2.0 - 3.0s	0.0 - 1.5s	1.5 - 2.0s	2.0 - 3.0s	0.0 - 1.5s	1.5 - 2.0s	2.0 - 3.0s
College Ave - Delaware Ave	24	17	28	105	0	0	10	14	23	85	3	5	10
N Walnut St - E Front St	24	22	36	153	0	0	1	20	29	135	2	7	17
US 13 - Hickory Ridge Rd/Spring Meadow Dr	24	0	1	3	0	0	3	0	1	0	0	0	0
Belltown Rd/Salt Marsh Blvd - Rd 285/Plantation Rd	24	22	72	317	21	71	315	1	0	2	0	1	0
Belltown Rd - US 9	24	0	2	12	0	0	6	0	2	3	0	0	3
Hudson Rd / Steamboat Landing Rd - DE 1	24	6	25	256	6	25	256	0	0	0	0	0	0
US 13 - US 9	24	2	2	4	1	2	3	1	0	1	0	0	0
Delaware Ave - SR 24 (Laurel Rd)	24	2	10	73	2	9	70	0	0	2	0	1	1

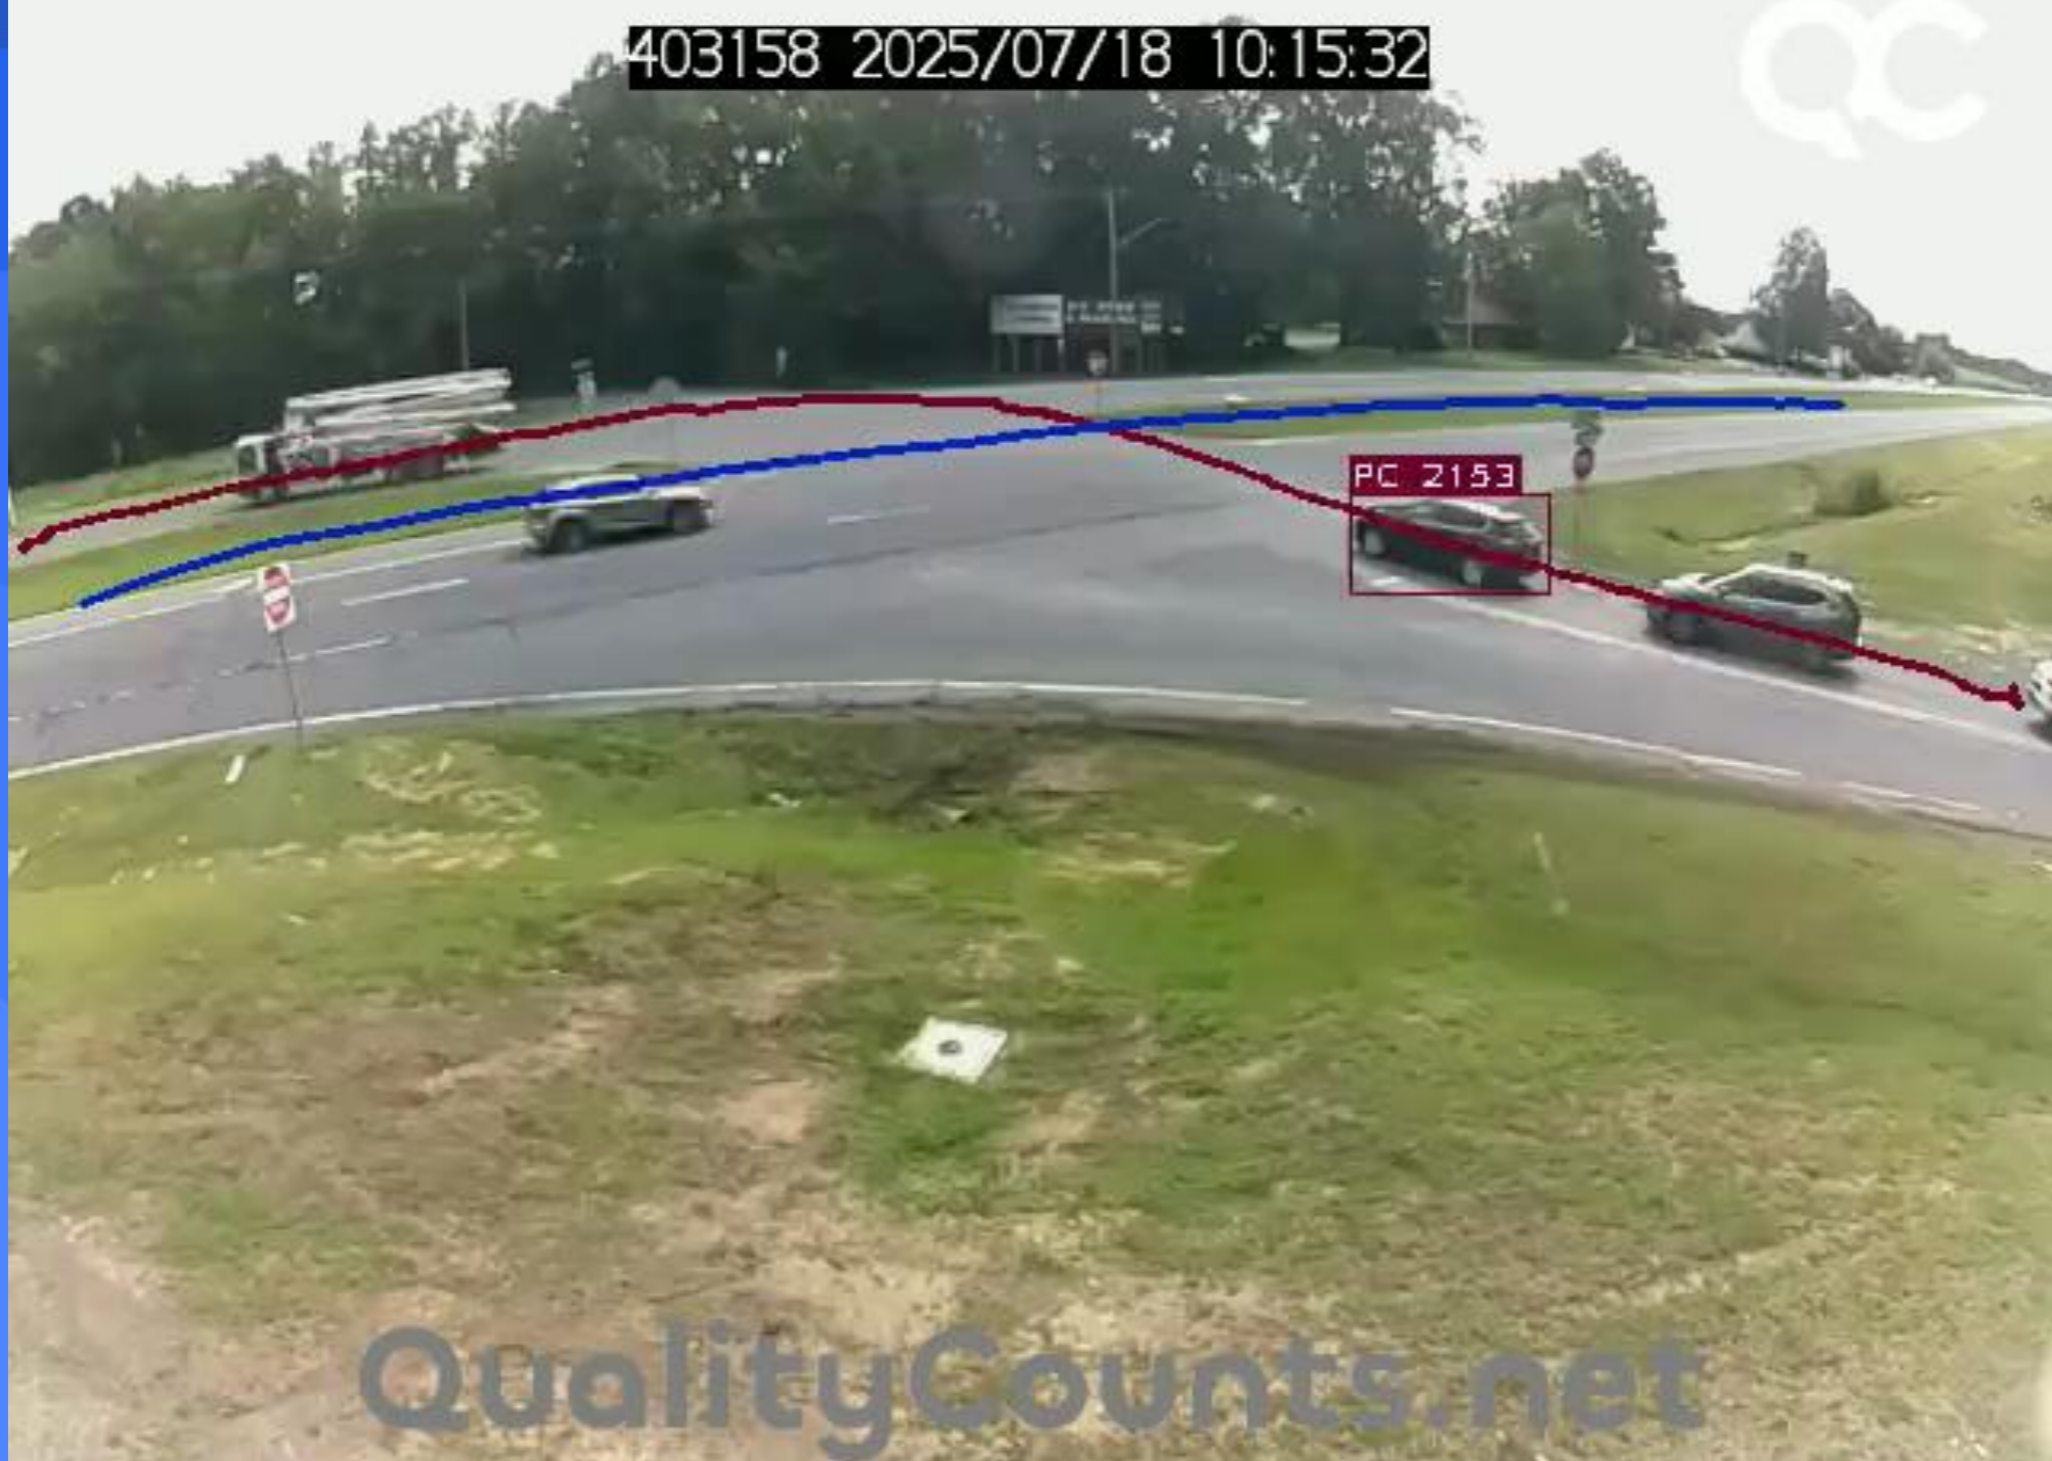
Veh-to-Veh

Near Misses	Conflict Rate
8	11%
National Avg	Percentile
8.6	58%
Average Thru Speeds	
--

Near Misses	Conflict Rate
9	4%
National Avg	Percentile
20.9	11%
Average Thru Speeds	
--

Near Misses	Conflict Rate
21	14%
National Avg	Percentile
20.9	61%
Average Thru Speeds	
--

Near Misses	Conflict Rate
231	14%
National Avg	Percentile
14.0	100%
Average Thru Speeds	
64.2

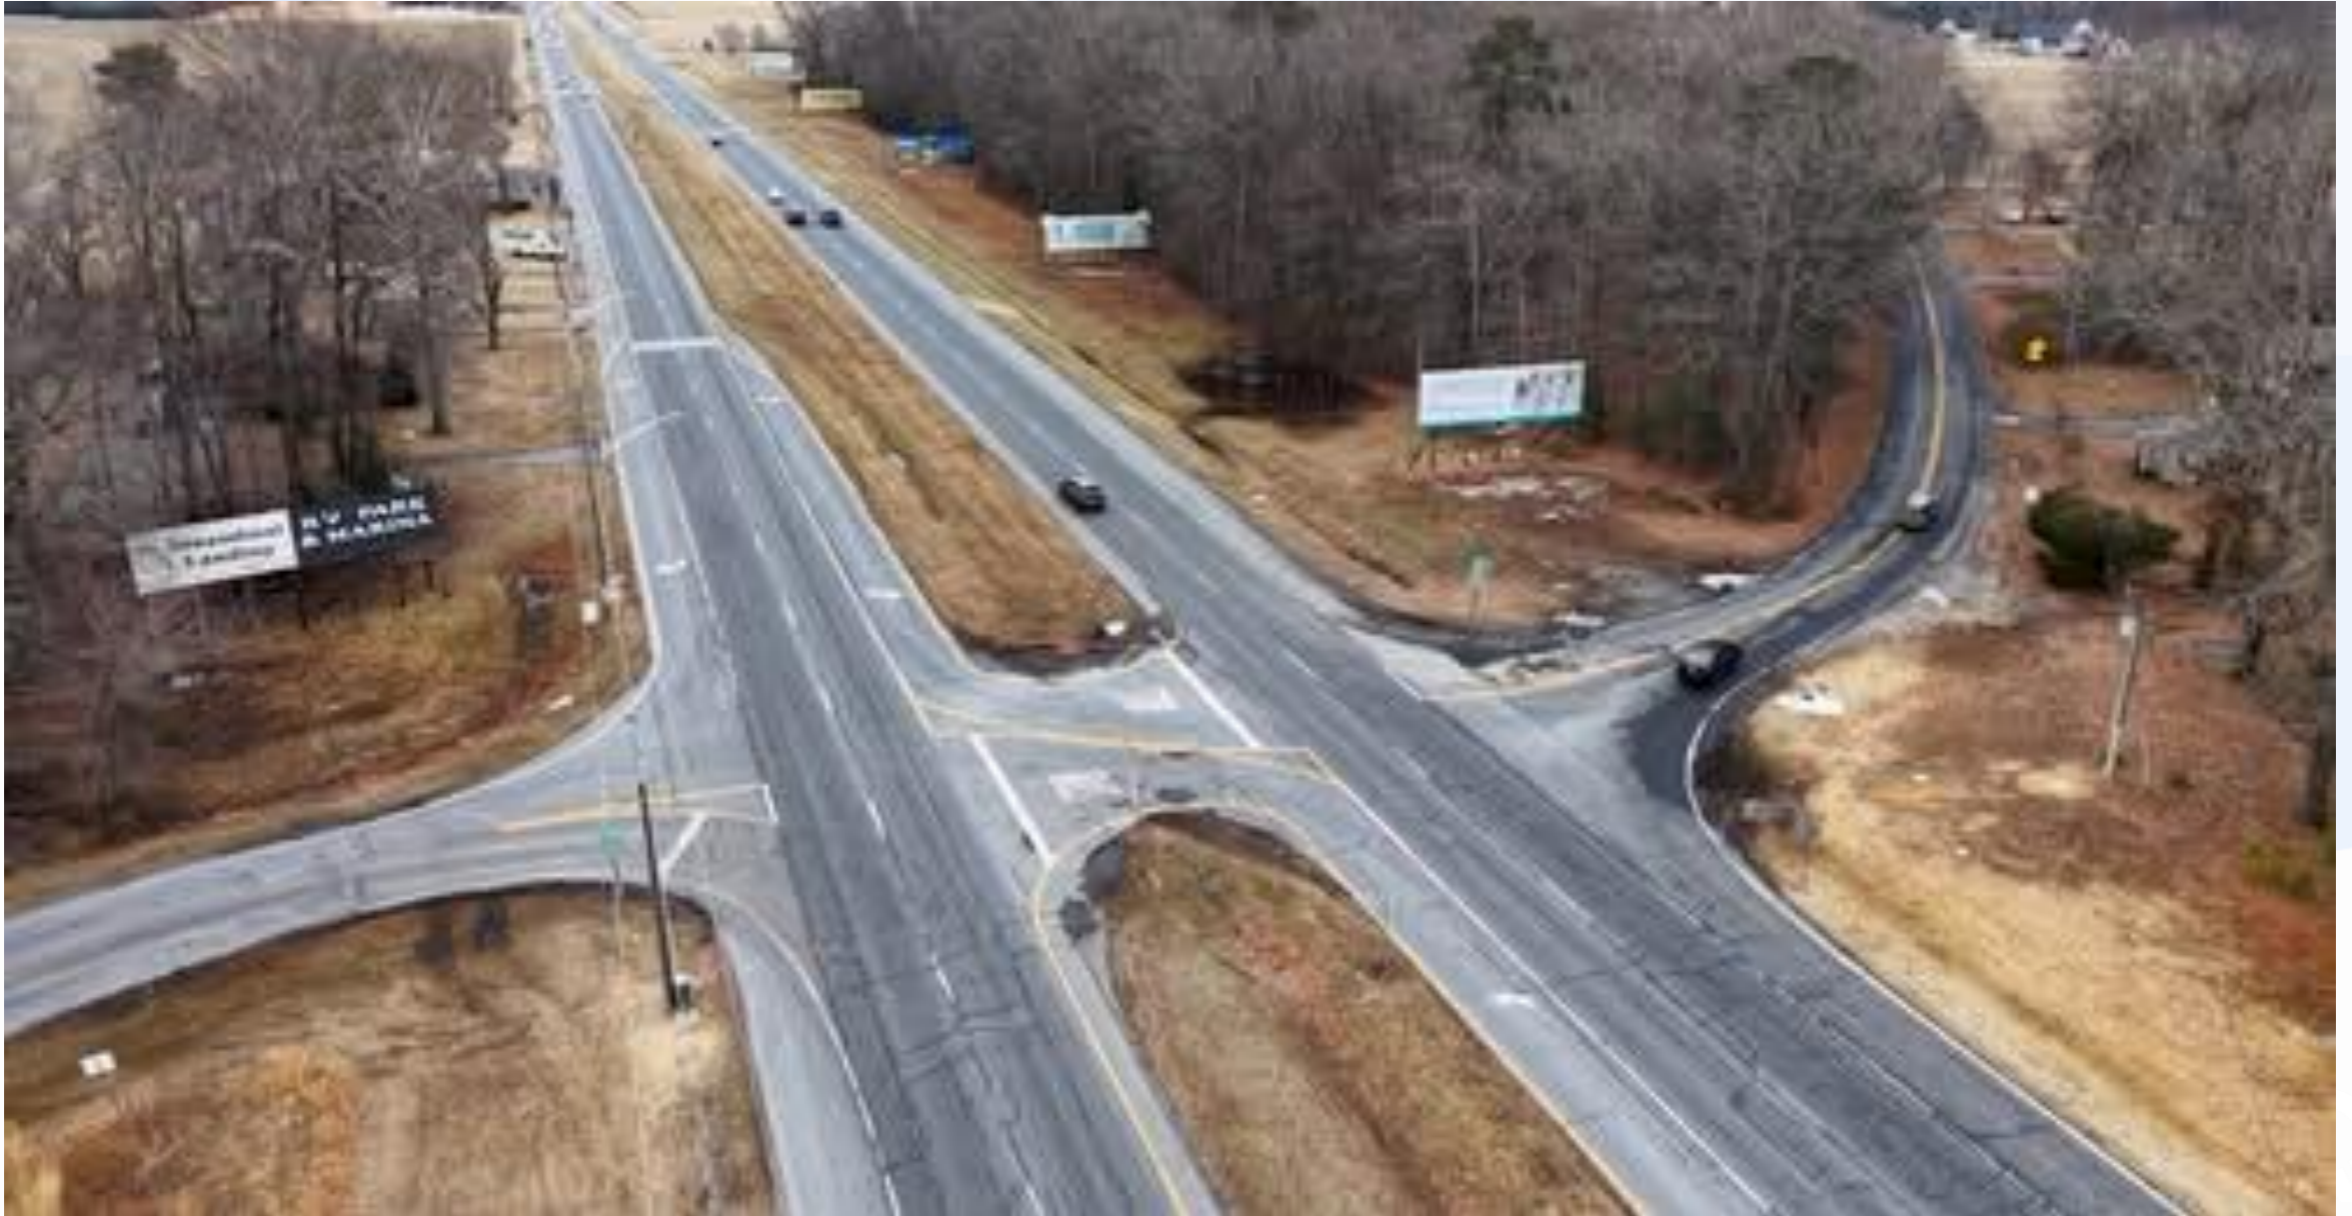
The Solution?

Hudson Rd – DE 1: After Study

Site Name	Total Hr	Total Conflicts			Veh - Veh Conflicts		
		0.0 - 1.5s	1.5 - 2.0s	2.0 - 3.0s	0.0 - 1.5s	1.5 - 2.0s	2.0 - 3.0s
Steamboat Landing Rd/Hudson Rd - Rt 1	120	0	6	67	0	6	67

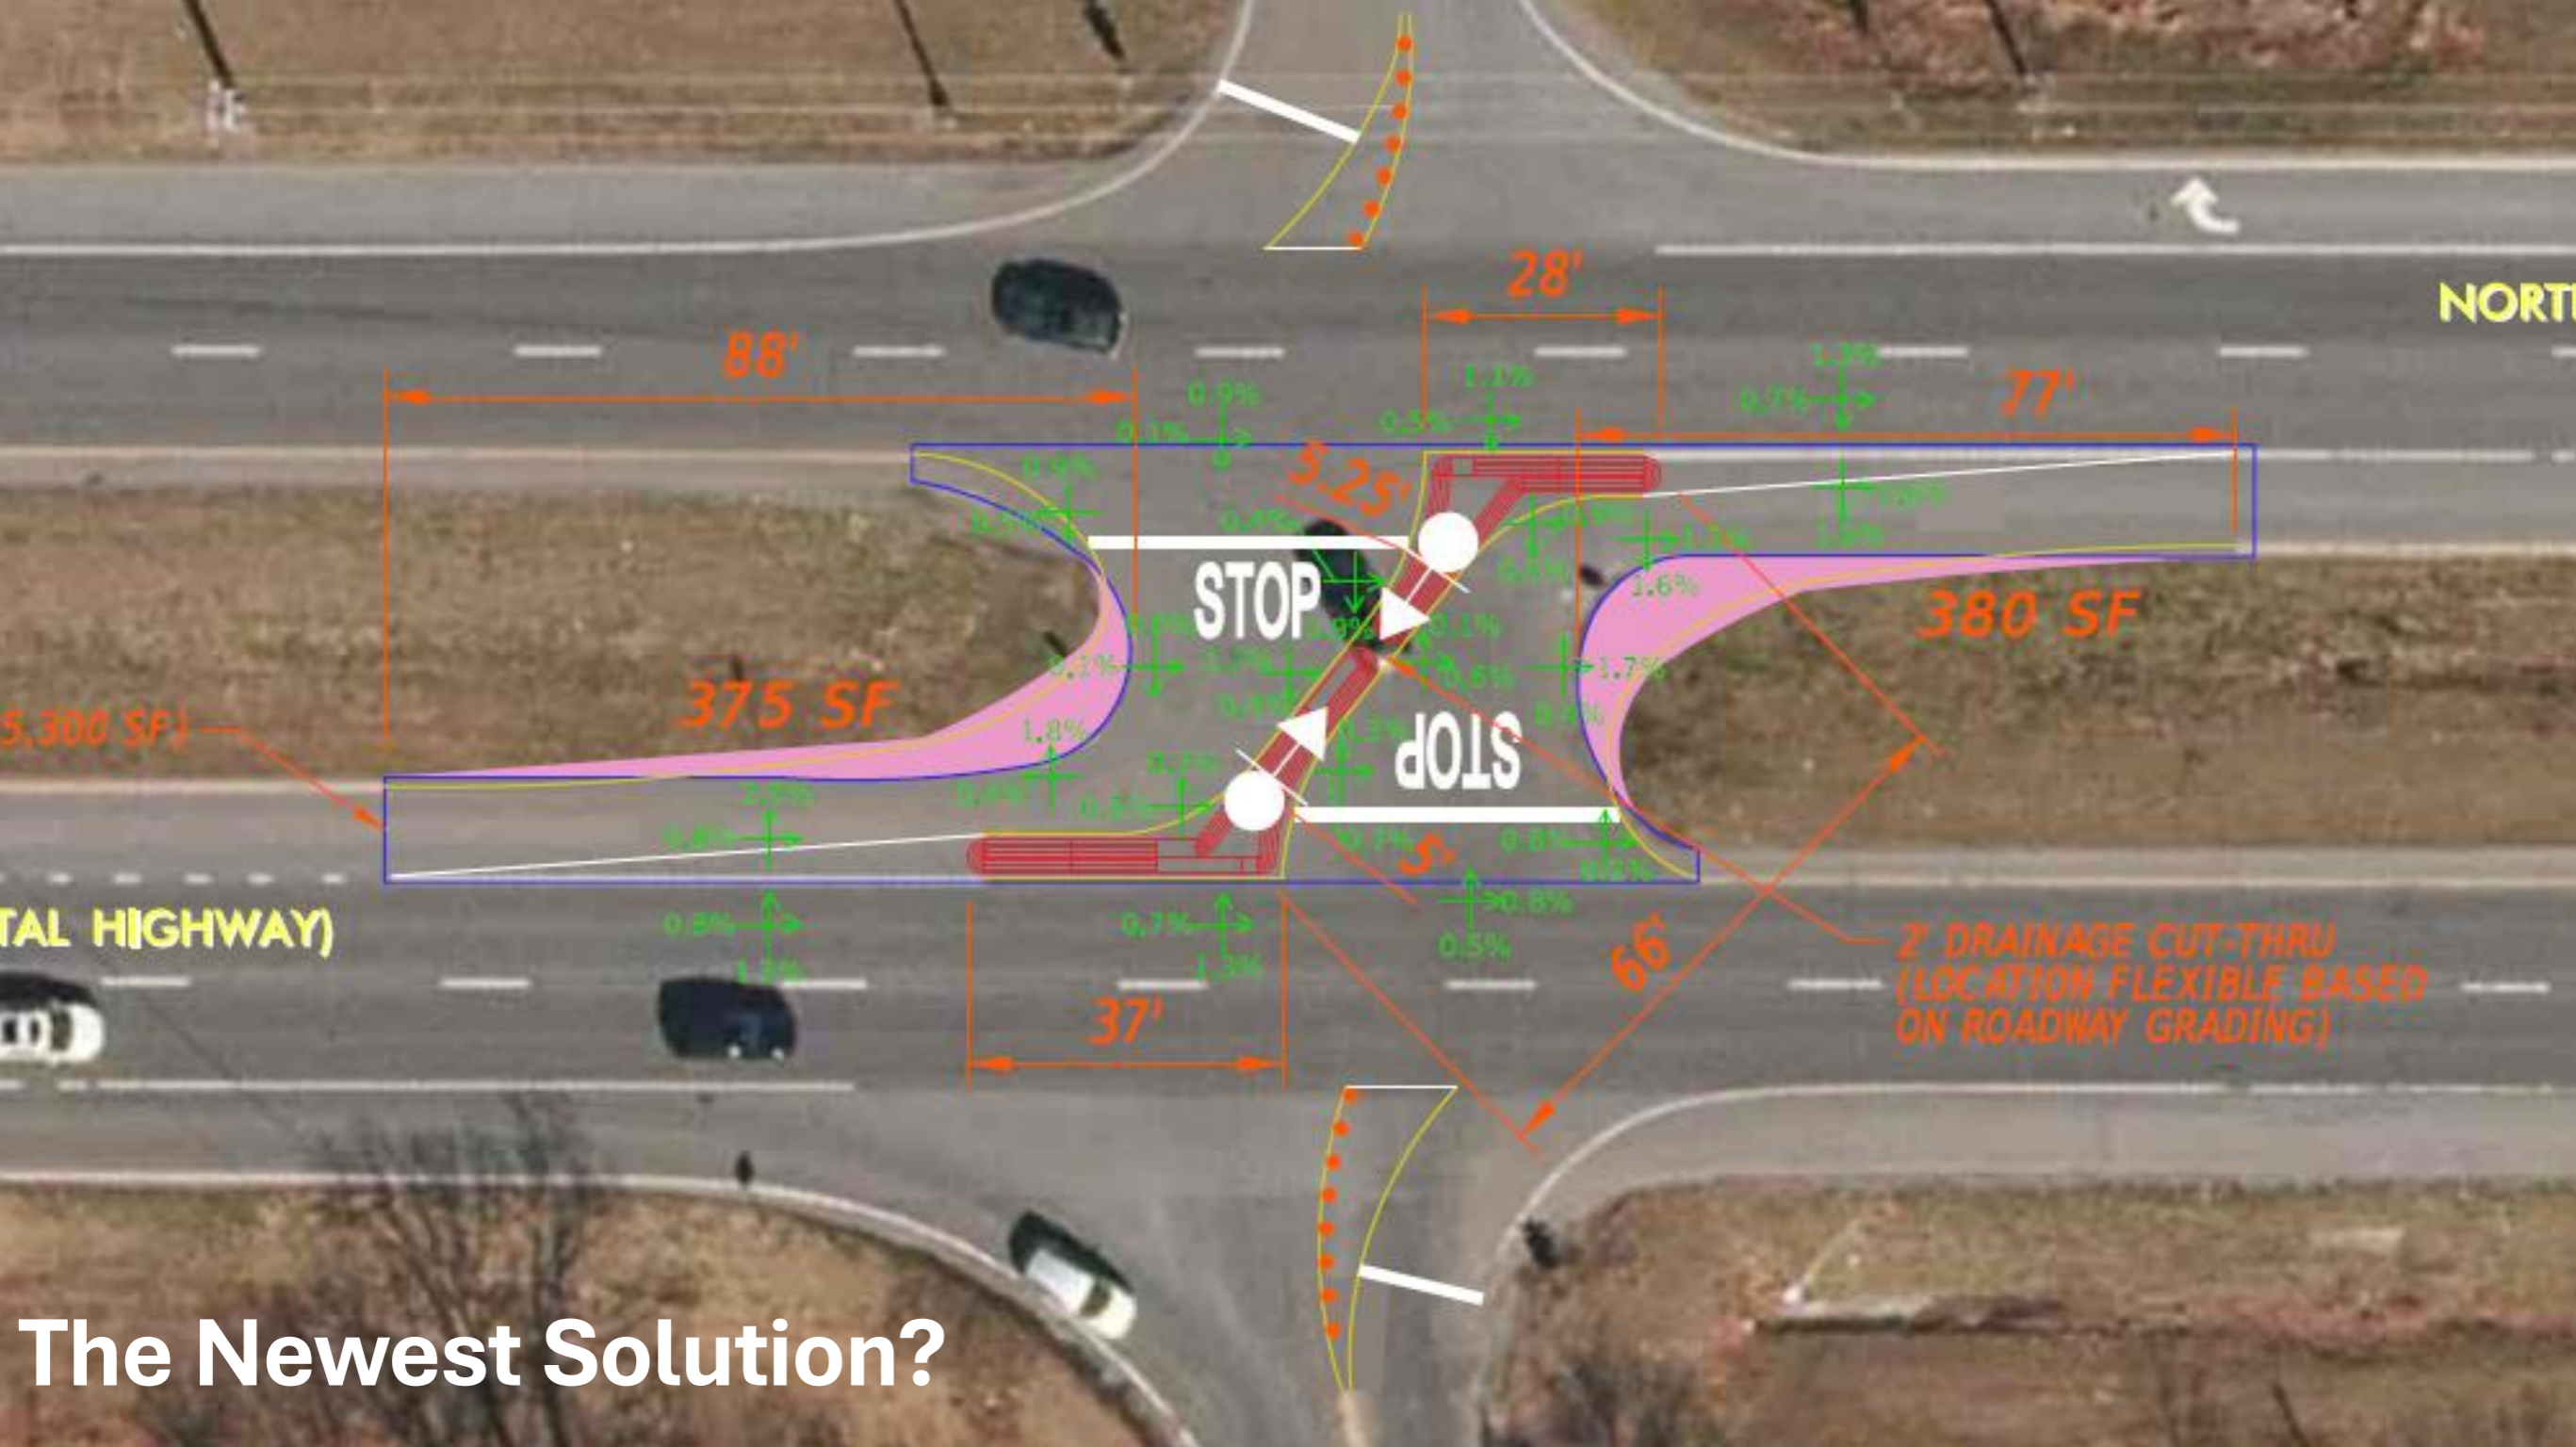
The Newest Solution?

2' DRAINAGE CUT-THRU
(LOCATION FLEXIBLE BASED
ON ROADWAY GRADING)

Hudson Rd – DE 1: After

DelDOT responded by restricting certain movements and directing drivers to make U-turns at designated crossovers. The change worked, as near misses dropped dramatically. But the follow-up study revealed something equally troubling: Many motorists simply ignored the new traffic pattern. Drivers continued to cross illegally through the median, often pushing through plastic delineators rather than merging southbound to make a legal U-turn. In doing so, they created new and potentially more dangerous conflicts.
